# Fracture Failure Analysis of Rear Axle Suspension Control Arm in Automobile

**Abstract:** Fracture failure occurred in the control arm of the rear axle suspension of a certain vehicle model. To determine the root cause of the failure, comprehensive analyses were conducted, including macroscopic fracture examination, microscopic fracture analysis, microstructural characterization, and hardness testing. The results indicate that the failure was caused by the combined effects of material defects, improper manufacturing processes, and service loading conditions. The fundamental cause of the fracture lies in the initiation of microcracks at the interface between coarse Al-Fe-Si-Mn inclusions and the matrix under cyclic loading. The presence of a strength gradient induced by local segregation of Si further accelerated crack propagation along the inclusion/matrix interface. Under cyclic stress, the cracks propagated progressively through a fatigue striation mechanism and exhibited intergranular fracture in the precipitation-enriched zones along grain boundaries. Ultimately, these factors led to premature fatigue failure of the control arm.

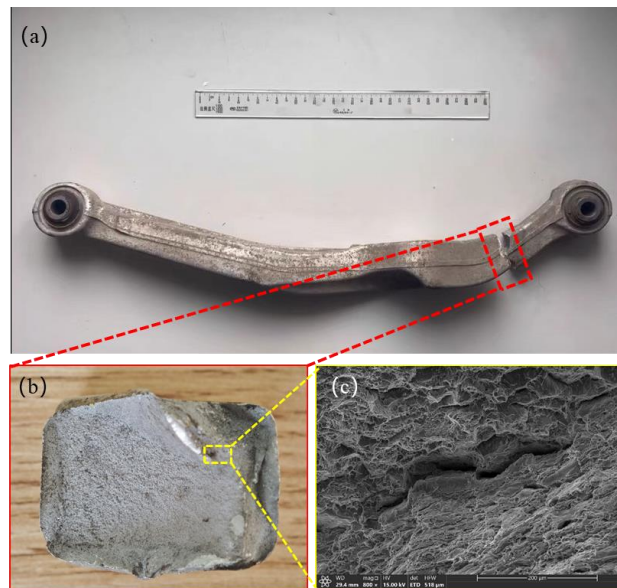
**Figure 1.** Fracture Location of the Elbow and Microstructure of the Fracture Surface

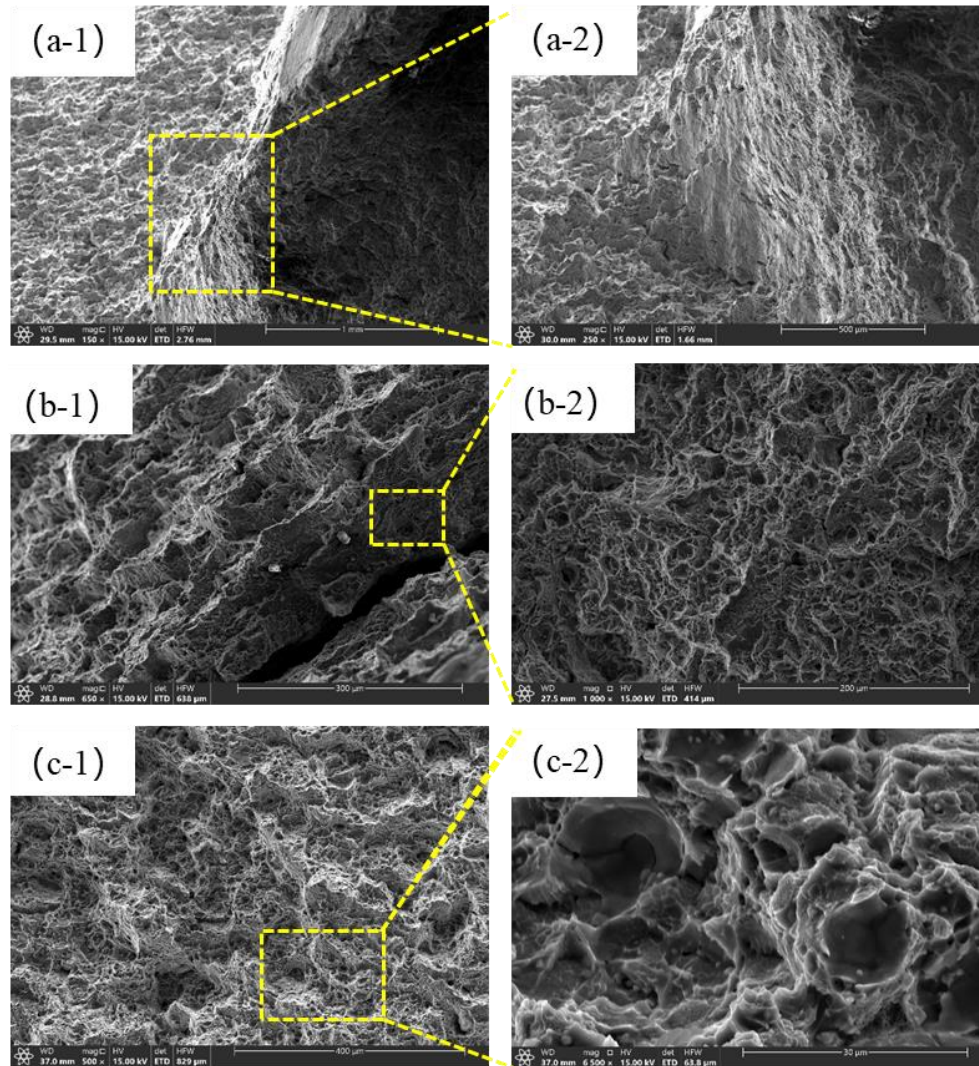
Microscopic examination of the fracture surface was conducted using the Zeiss Gemini 300 field emission scanning electron microscope to reveal the underlying fracture mechanisms and failure processes of the aluminum alloy component. The observations confirmed characteristic features of fatigue fracture, with the fracture surface clearly divided into three distinct regions based on morphological differences: the fatigue initiation zone, the final fracture zone, and the crack propagation zone (Figure 3).

**Figure 3.** Fracture Surface morphology of the fracture surface.

In the fatigue initiation zone (corresponding to Figures a-1 and a-2), two distinct crack initiation sites were identified. The first originated from a relatively large surface pit, approximately 0.5 mm in depth and 0.8 mm in width. SEM images revealed fatigue striations radiating toward the center of this defect. The second crack initiation site was associated with a machining-induced tool mark, approximately 0.4 mm in depth. A clear fatigue edge line can be seen radiating outward from the root of the tool mark, located in the R-angle transition zone of the key force-bearing part of the component.

The microscopic morphology of the final fracture zone (corresponding to Figures b-1 and b-2) is primarily characterized by flat cleavage steps and typical river patterns. In some localized areas, small dimples are also observed. This brittle fracture morphology dominates a large portion of the overall fracture surface.

The crack propagation zone (corresponding Figure c-1 and c-2) shows typical fatigue fracture characteristics, including obvious cleavage patterns, fatigue bands about 2-3  $\mu\text{m}$  apart, and multiple interleaved secondary cracks.

The cracks derived from the machining tool marks and their radial fatigue edges fully demonstrate the crucial influence of surface machining quality on fatigue performance. Especially the tool marks located in the transition zone of the R-angle, their formation may be related to the "tool shaking" phenomenon, significantly reducing fatigue life. The morphological characteristics of the crack propagation zone reflect that the component has been subjected to high stress amplitude and low-frequency cyclic loads. Multiple secondary cracks further confirm that the material exhibits obvious brittle features during fatigue propagation. The fatigue band spacing can be used to quantitatively evaluate the crack propagation rate and stress level.

The final fracture zone is characterized by the morphology of cleavage steps and river patterns, combined with their relatively large proportion, indicating that rapid brittle fracture occurred when the crack reached the critical size. The river pattern indicates the direction of crack propagation, and the height of the cleavage steps reflects the brittleness degree of the material. Comprehensive analysis indicates that the fracture of this aluminum alloy component is a typical multi-source fatigue fracture and fails in a brittle manner. The main reasons include: Stress concentration caused by surface quality defects (pits and tool marks) (the most critical factor), insufficient toughness of the material itself, and alternating loads with high stress amplitudes.

Based on the above analysis, several improvement measures are recommended: First, the machining process parameters should be optimized, with strict control over surface quality, especially in critical load-bearing areas, to ensure surface integrity. Second, surface treatment techniques such as shot peening may be considered to improve the residual stress state at the surface. Third, in terms of material selection, it is advisable to use aluminum alloys with higher fracture toughness or to optimize the heat treatment process of the current alloy to enhance ductility. Fourth, the heat treatment protocol should be refined to promote sufficient elemental diffusion and eliminate strength gradients. A well-designed heat treatment schedule can also facilitate the spheroidization of silicide phases and reduce stress concentrations around precipitates. Lastly, from a structural design perspective, increasing the fillet radius in transition regions and optimizing load-bearing geometry can effectively reduce stress concentration. These improvement strategies should be evaluated and selected based on actual service conditions and cost considerations to ensure both performance and manufacturability.
